Līhu'e Wastewater Treatment Plant
Trickling Filter/Solids Contact
Condition Assessment

Prepared for
County of Kaua'i, Department of Public Works
Wastewater Management Division
Līhu'e, Hawaii
September 22, 2014

Project Title: Lihu'e Wastewater Treatment Plant
Biotower and Clarifier Startup and Optimization Engineering Services Project

Subject: Trickling Filter/Solids Contact Condition Assessment

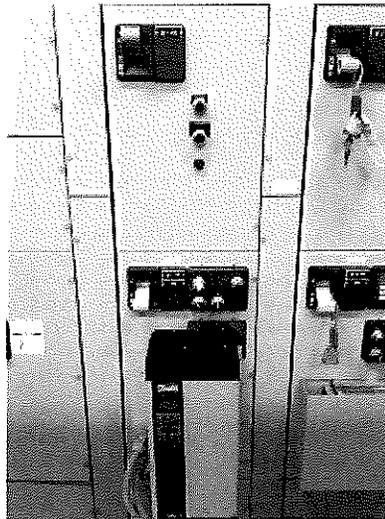
The biofilter speed motor control is fed via the MCC located in the main electrical building which was installed in mid 1990s. The drive motor for the biofilter has the option to be driven via a constant-speed across-the-line starter or a VFD. The existing across-the-line starter appeared to be in adequate condition. The existing VFD is a Danfoss VLT type drive installed/attached to the exterior of the MCC and appears to have been installed after the original MCC installation in the mid 1990s. Per communications with Eaton, installation of a 3rd party VFD (Danfoss type VFD as shown in Figure 4-1) on the front face of the MCC will void the UL listing of the MCC. Additionally, installation instructions from Eaton specifically prohibit installation of devices other than selector switches and pilot devices to the front face of the MCC bucket door, as the MCC dead front type construction is not designed for this application. These VFDs should be replaced with VFDs installed within the MCC and manufactured by Eaton or replaced with VFDs installed external to the MCC line-up. Where VFDs are installed outside of the MCC line, any manufacturer could be used as a replacement.

Figure 4-1. Biofilter Starter (Top) and Danfoss VFD (Bottom)

A control panel (PNL 21101) is installed at the top of Biofilter 1 containing remote flow indicators and an adjustable potentiometer intended for manual speed control of the biofilter drive motor. It was evident from inspection that water has been intruding into the control panel for some time, rendering the elements located within nonfunctional. The flow transmitters associated with the flow indicators are installed at the base of Biofilter 1 and are also inoperable. It is recommended that these be replaced if flow indication is desired.

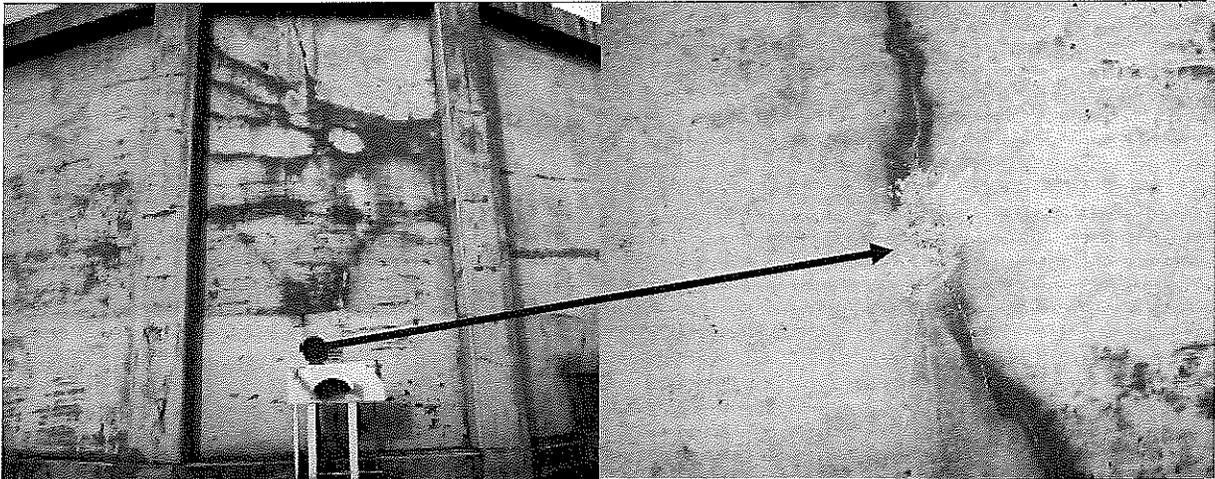
In general, the structure appears to be in fair to good condition with some minor discrepancies. Some minor hairline cracks were located randomly throughout the precast wall panels and at each column. The cracks appear to be non-structural shrinkage cracks and limited to only the exterior cement-wash coating over the structural elements. After scratching off the cement-wash coating layer, the cracks do not appear in the structural elements (See Photos 1 & 2).

Photo 1- Typical Wall Panel and Columns

Photo 2- Crack in Cement-Wash Coating

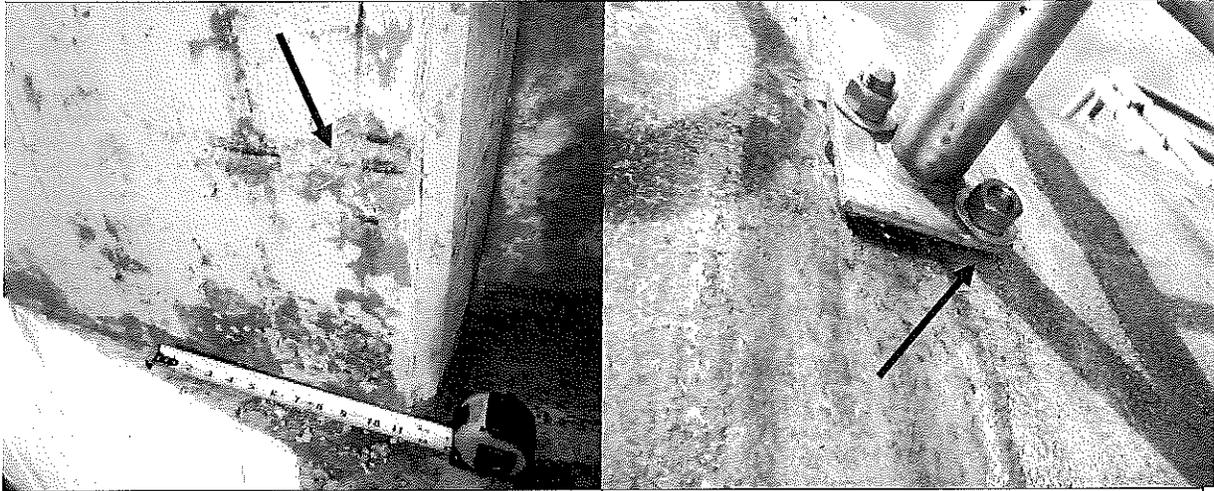
At the south-east quadrant of the biofilter, one concrete column had some minor concrete spalls at the base that exposed the embedded reinforcing steel (See Photo 3). The rebars appear to be in good condition with no noticeable signs of advanced corrosion. After sounding this location with a small hammer, the spalling appears to be localized and limited only to that portion surrounding the exposed rebar. The concrete cover in this location is less than one inch, which is less than the original contract drawing requirements and may not provide adequate protection for long-term durability.

The metal access ladder connection to the interior face of the concrete wall is incomplete (See Photo 4). No other signs of significant structural distress were noted and no apparent signs of foundation settlement were observed.

Photo 3- Exposed Rebar at Column Base

Photo 4- Access Ladder Connection

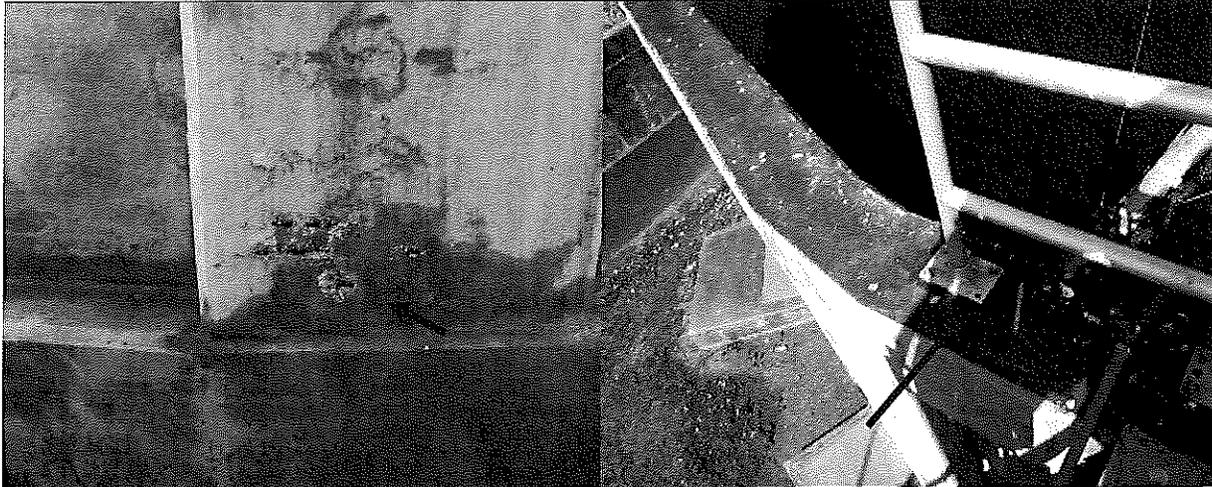
One metal guardrail post near the gate at top of the Biofilter is missing an anchor bolt (See Photo 6).

Photo 5- Exposed Rebar at Column Base

Photo 6- Missing Anchor Bolt at Guardrail

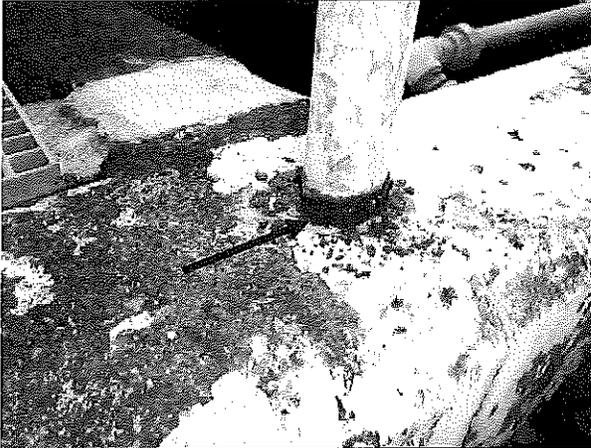
The steel railing all around the existing tank is in fair to poor condition with some moderate corrosion at the joints (See Photo 7). The coating of the railing has mostly failed and is peeling off the substrate. Some minor holes were cut out of the steel grating, leaving the grating unsupported at small sections (See Photo 8). Various steel angles and plates supporting the wood baffles and elevated walkways exhibit signs of minor corrosion (See Photos 9 & 10). The wood baffles, which separate the sections of the tank, are in poor condition, exhibiting signs of wood rot (See Photos 10 & 11). Finally, there are various random narrow shrinkage cracks and concrete spalls located throughout the top of the concrete tank (See Photo 12).

Photo 7- Corrosion at Joints of Railing

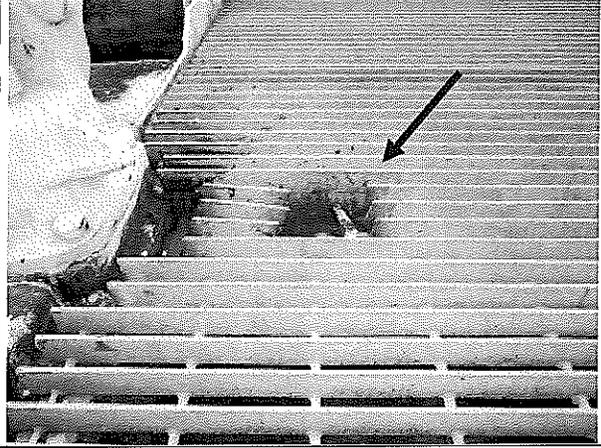
Photo 8- Holes Through Steel Grating

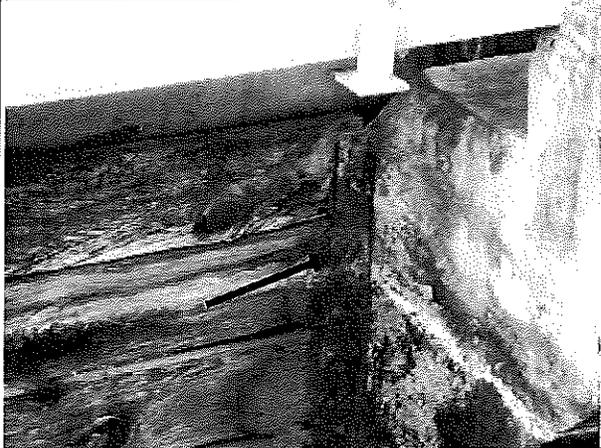
Photo 10- Corrosion of Steel Angle Brackets

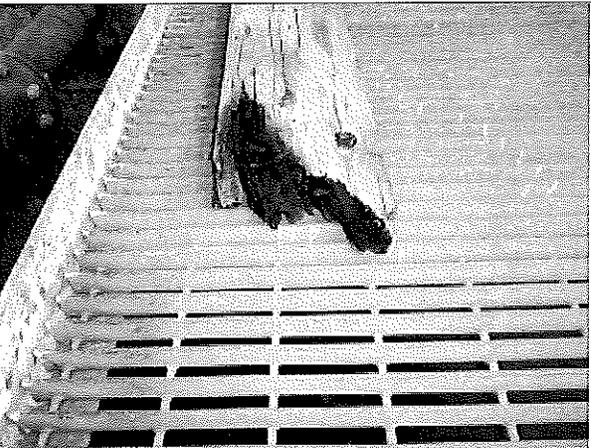
Photo 11- Wood Rot of Baffles

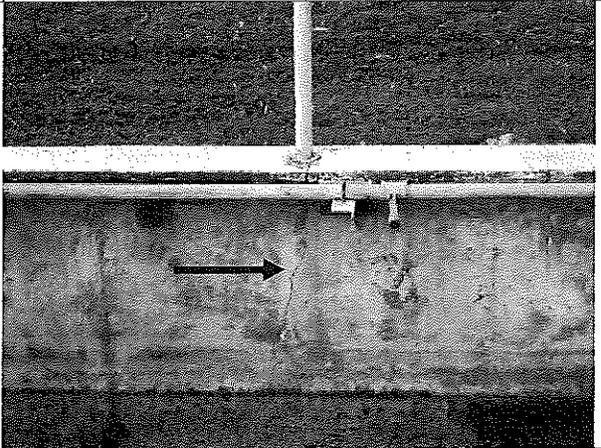
Photo 12- Shrinkage Cracks at Top of Walls

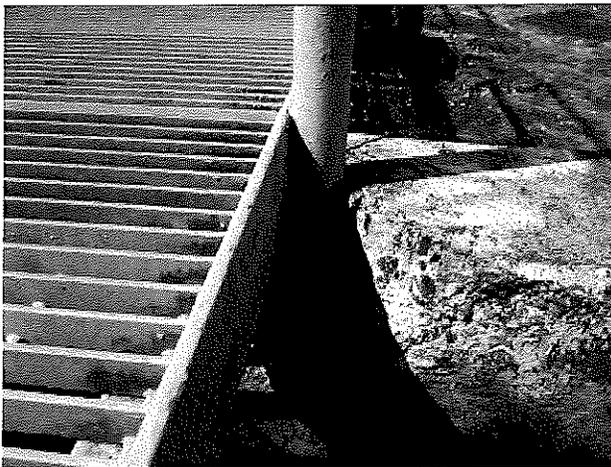
The steel railing all around the existing tank is in poor condition with some moderate to severe corrosion at the post bases (See Photo 13). Some of the railing posts along the center walkway were missing or intentionally removed (See Photo 14). And similar to ASC Tank 1, steel bar grates were cut and minor spalls and cracks were present at the top of the concrete walls.

Photo 13- Corrosion of Post Base Leading to Concrete Spall

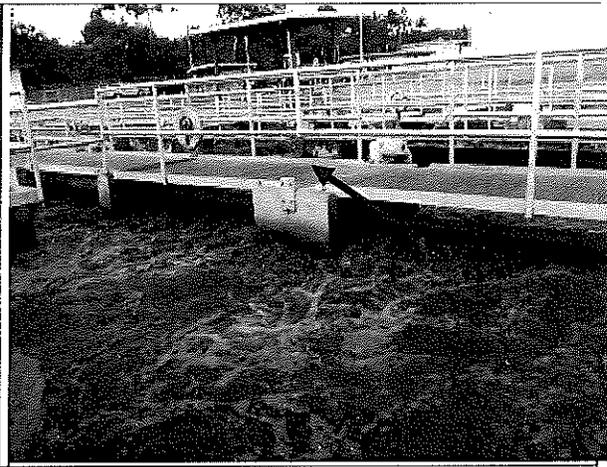
Photo 14- Missing Railing Post

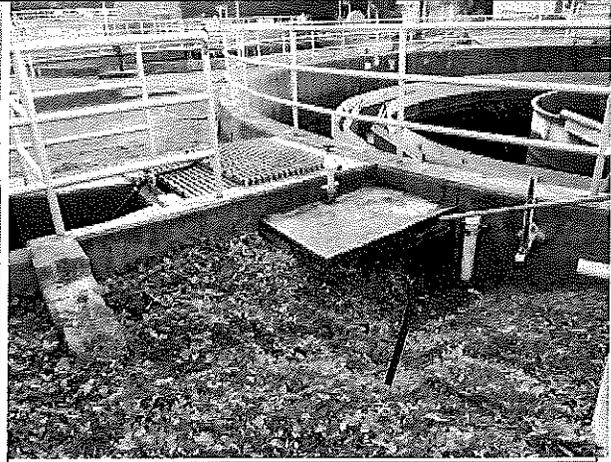
In general, the structure appears to be in fair to good condition with minor discrepancies. At the northeast quadrant, a section of a slab on grade landing platform has been undermined (See Photo 16).

It is unclear the cause of the undermining, though an outlet pipe shown in the photo below may be the cause.

Photo 16- Slab on Grade Undermining

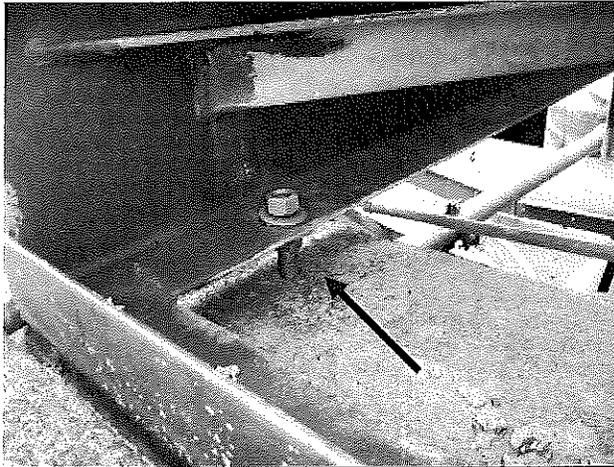
The steel beams supporting the FRP walkway appear to be in good condition. At the ends of the beams, a gap exists between the beam bottom and the supporting concrete wall (See Photo 17). In addition, the FRP grating is the original grating installed during construction of the tank and it may be near the end of its useful life due to exposure to UV rays.

Photo 17- Gap Beneath Beams

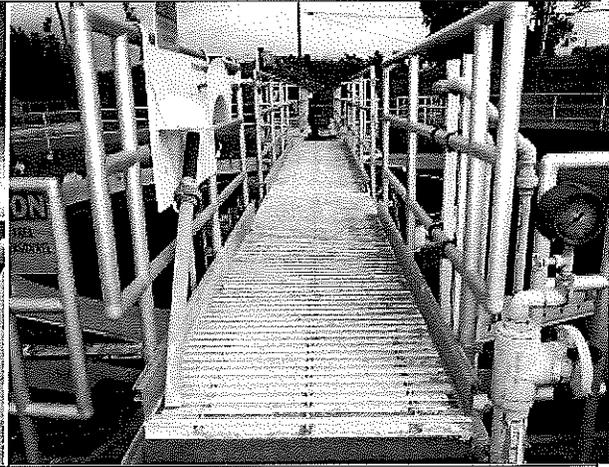
Photo 18- FRP Grating

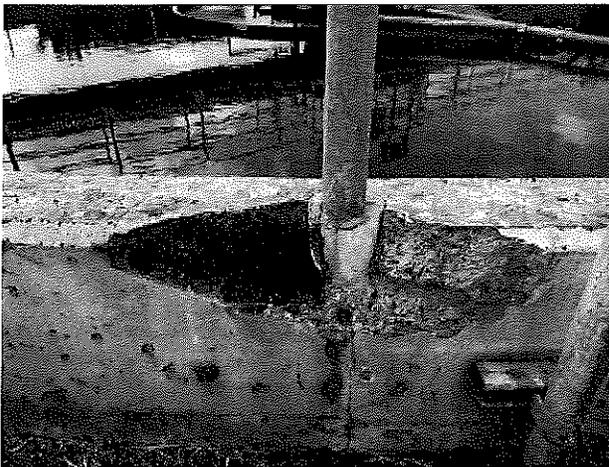
In general, the structure appears to be in fair condition with moderate discrepancies. Numerous vertical cracks with widths averaging 0.03 inches and spalls occur at the steel railing post locations (See Photos 19 & 20). The cracks and spalls are likely due to corrosion of the steel post bases, but could be compounded by several factors including: a) the clarifier walls are only 8 inches thick at the top, b) the post base sleeve reduces the concrete cover on either side of the post to thin sections, and c) there is no horizontal reinforcing steel at these locations to limit the cracking. ACI 350 recommends a minimum wall thickness of 12" for concrete structures in contact with liquids.

Photo 19- Concrete Spall at Railing Post Base

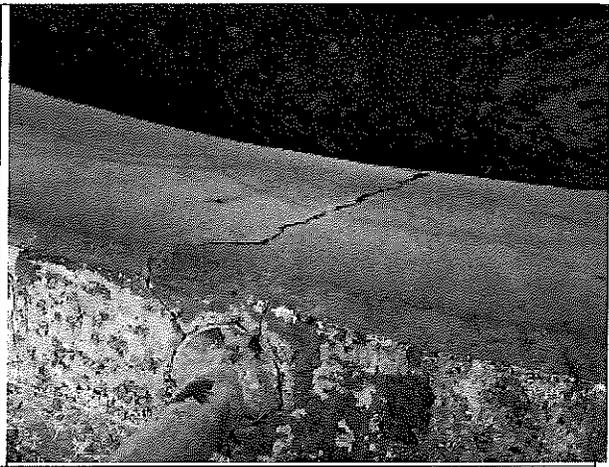
Photo 20- Vertical Crack at Top of Concrete Wall

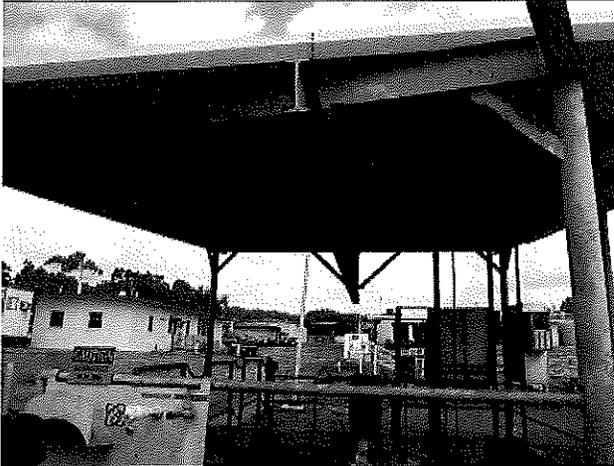
Photo 21- Steel Canopy Structure

An open canopy structure consisting of steel beams and pipe columns and metal roofing is located adjacent to Secondary Clarifier 2. It provides protection against weather for RSS Pump Station 2. The original date of construction is assumed to be the 1990s. In general, the structural framing appears to be in fair condition with mostly minor to moderate isolated corrosion of the steel beams. The most severe corrosion occurred at the top flange of the steel beam below the roof gutter, which resulted in some section loss of the top flange. (See Photo 22) There may be a leak in the gutter at this location which may be accelerating the steel corrosion.
